# Arboricultural Impact Assessment and Development Impact Report

Site: Port Adelaide Football Club

Date: Tuesday, 29 June 2021

ATS6119-PAFCDIR R1

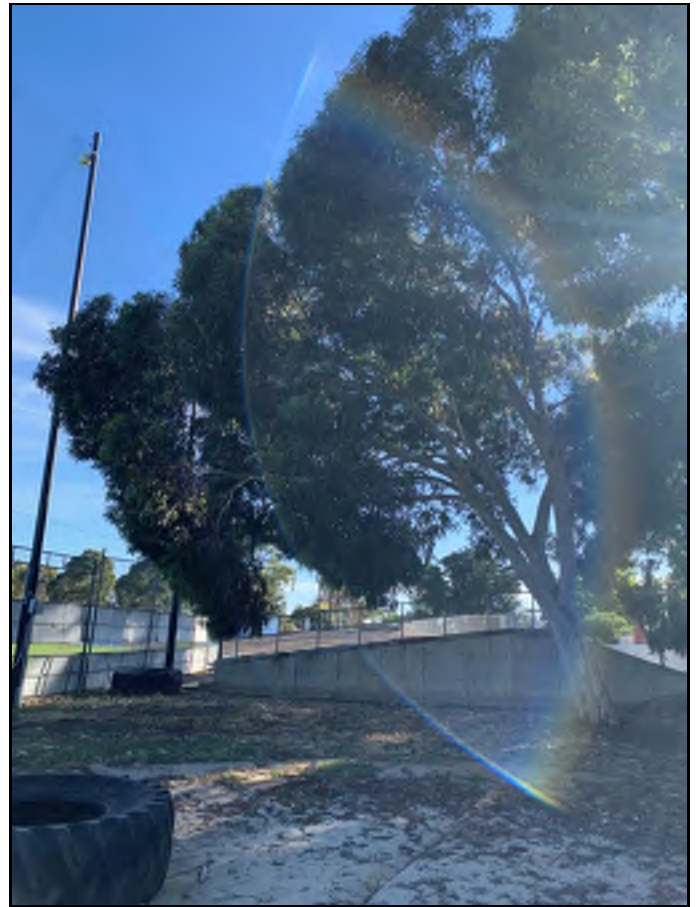
The health and structure of this tree indicate it is in good overall condition and has adapted to its local environment.

Protect the root zone of this tree in accordance with the recommendations and principles of AS4970-2009.

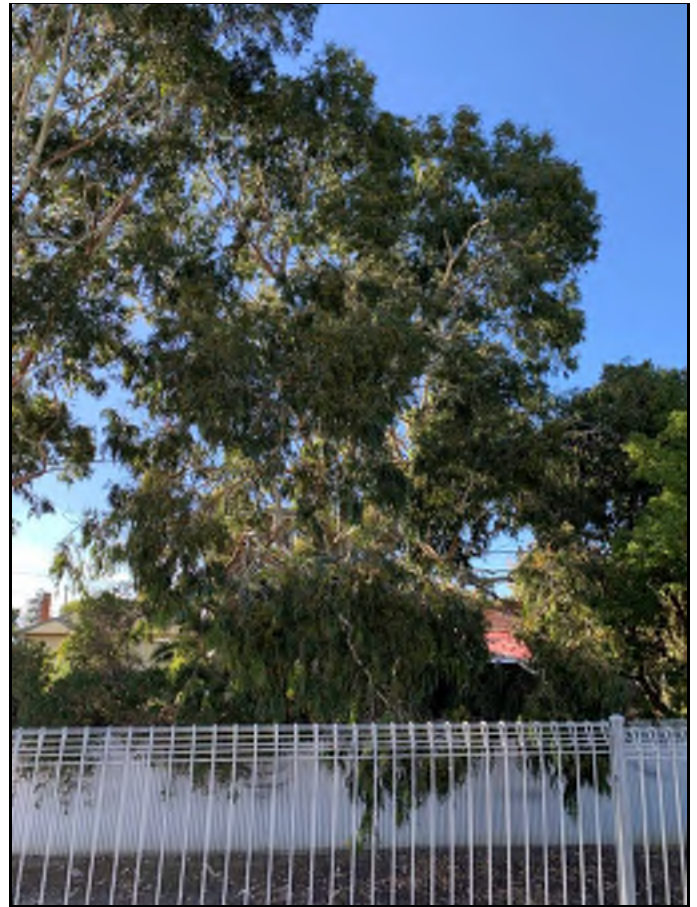
The health and structure of this tree indicate it is in good overall condition and has adapted to its local environment. This tree is located on an adjacent property and therefore measurements have been estimated due to access availability.

Legislative Status	Regulated
This tree has a trunk circumference greater than two metres and is not subject to any exemption from regulation and therefore it is identified as a Regulated Tree as defined in the Planning, Development and Infrastructure Act 2016.	
Retention Rating	High
This tree has a High Retention Rating and should be protected in any future development.	
Development Impact	No Impact
No encroachment into the Tree Protection Zone area has been identified.	
Recommendation	Protect Root Zone
Protect the root zone of this tree in accordance with the recommendations and principles of AS4970-2009.

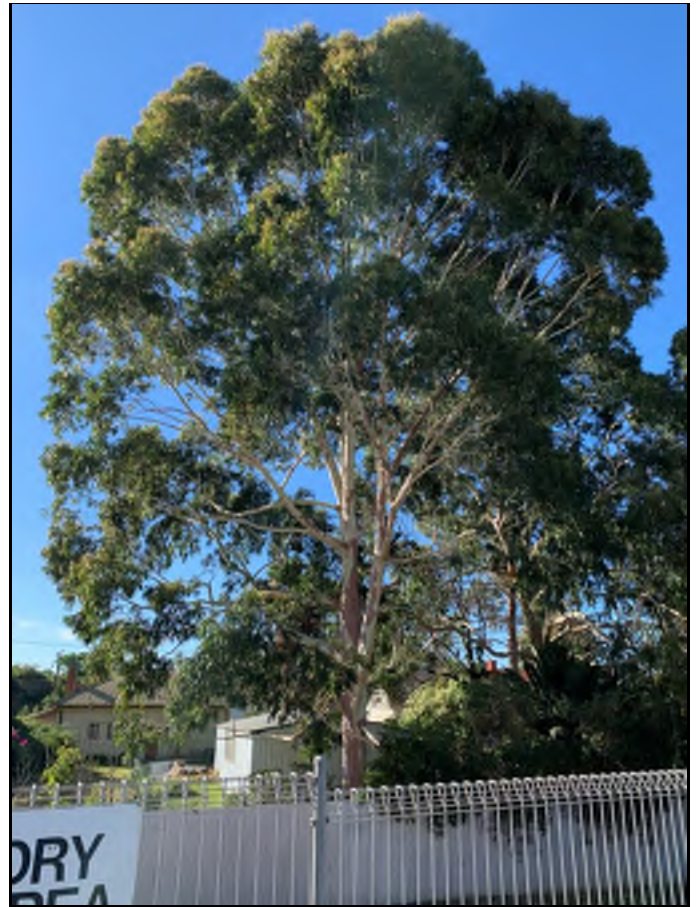
The health and structure of this tree indicate it is in good overall condition and has adapted to its local environment. This tree is located on an adjacent property and therefore measurements have been estimated due to access availability.

Legislative Status	Regulated
This tree has a trunk circumference greater than two metres and is not subject to any exemption from regulation and therefore it is identified as a Regulated Tree as defined in the Planning, Development and Infrastructure Act 2016.	
Retention Rating	High
This tree has a High Retention Rating and should be protected in any future development.	
Development Impact	Low
The identified encroachment is less than 10% of the TPZ area and not expected to impact tree viability.	
Recommendation	Protect Root Zone
Protect the root zone of this tree in accordance with the recommendations and principles of AS4970-2009.

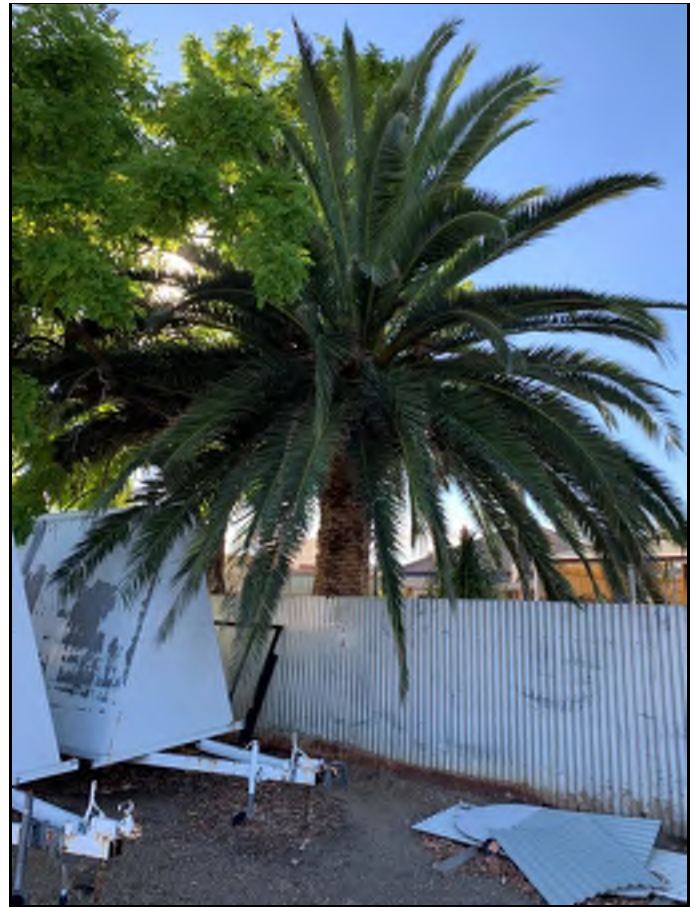
The health and structure of this tree indicate it is in good overall condition and has adapted to its local environment. This tree is located on an adjacent property and therefore measurements have been estimated due to access availability.

Protect the root zone of this tree in accordance with the recommendations and principles of AS4970-2009.

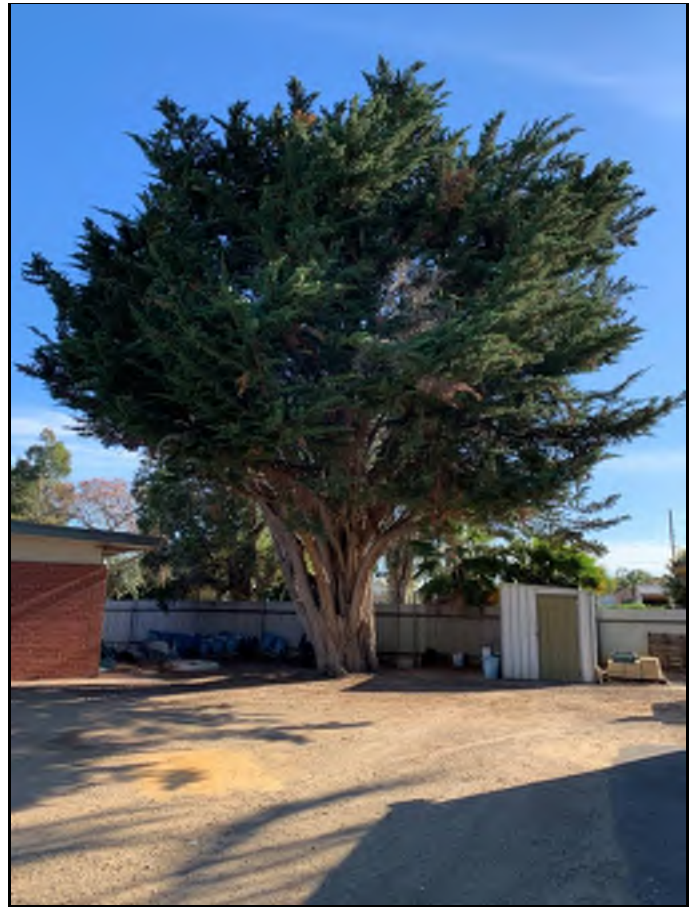
This tree is considered to be in fair overall condition as evidenced by the moderate volume of deadwood and dieback throughout the crown and the species typical stable included bark unions throughout the structure.

Legislative Status	Exempt
This tree species is listed as exempt from control under Regulation 3F(4)(b) of the Planning, Development and Infrastructure (General) Regulations 2017.	
Retention Rating	Low
This tree has a Low Retention Rating and should not form a material constraint to the redevelopment of this site.	
Development Impact	Conflicted
The identified encroachment is greater than 10% of the TPZ area and will also impact the SRZ and the trunk. There is no opportunity to retain this tree in the current design and its removal is required as part of the development.	
Recommendation	Removal Required
Tree removal is required to support the proposed development.

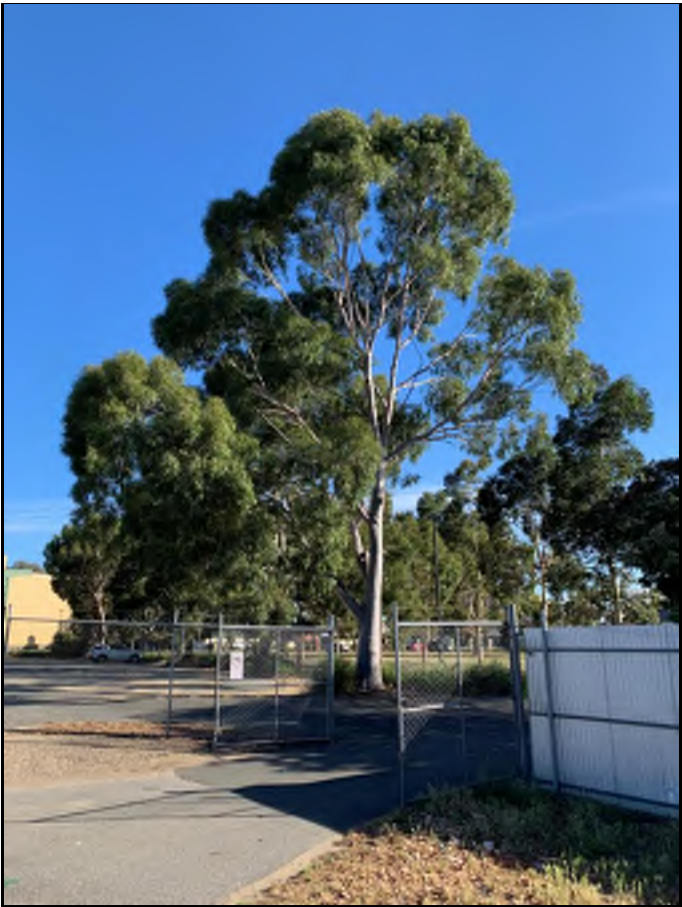
The health and structure of this tree indicate it is in good overall condition and has adapted to its local environment.

Legislative Status	Regulated
This tree has a trunk circumference greater than two metres and is not subject to any exemption from regulation and therefore it is identified as a Regulated Tree as defined in the Planning, Development and Infrastructure Act 2016.	
Retention Rating	High
This tree has a High Retention Rating and should be protected in any future development.	
Development Impact	Conflicted
The identified encroachment is greater than 10% of the TPZ area and will also impact the SRZ and the trunk. There is no opportunity to retain this tree in the current design and its removal is required as part of the development.	
Recommendation	Removal Required
Tree removal is required to support the proposed development.

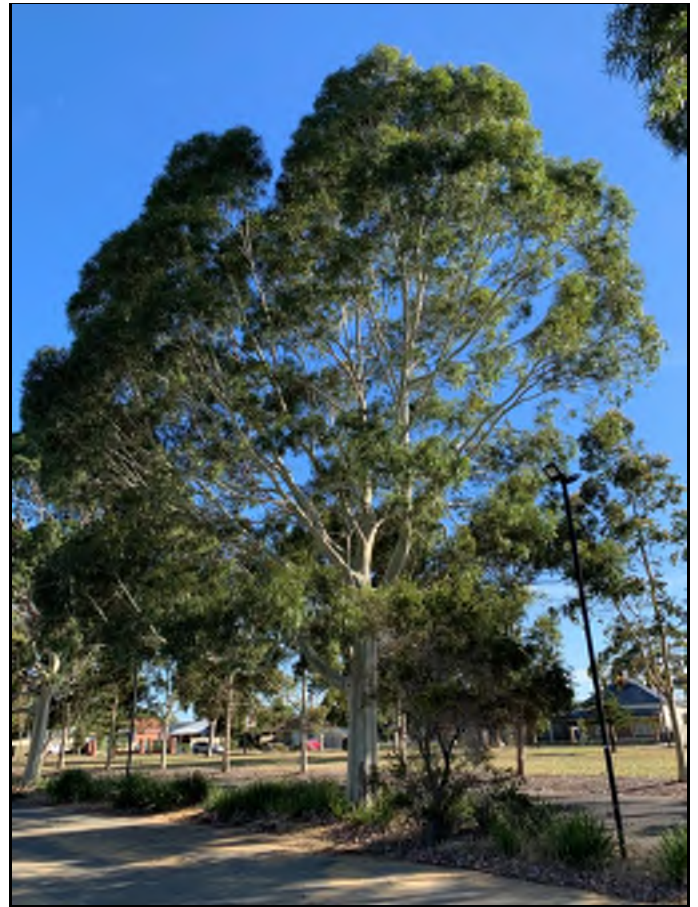
The health and structure of this tree indicate it is in good overall condition and has adapted to its local environment.

<b>Legislative Status</b>	<b>Regulated</b>
This tree has a trunk circumference greater than two metres and is not subject to any exemption from regulation and therefore it is identified as a Regulated Tree as defined in the Planning, Development and Infrastructure Act 2016.	
<b>Retention Rating</b>	<b>High</b>
This tree has a High Retention Rating and should be protected in any future development.	
<b>Development Impact</b>	<b>Conflicted</b>
The identified encroachment is greater than 10% of the TPZ area and will also impact the SRZ and the trunk. There is no opportunity to retain this tree in the current design and its removal is required as part of the development.	
<b>Recommendation</b>	<b>Removal Required</b>
Tree removal is required to support the proposed development.

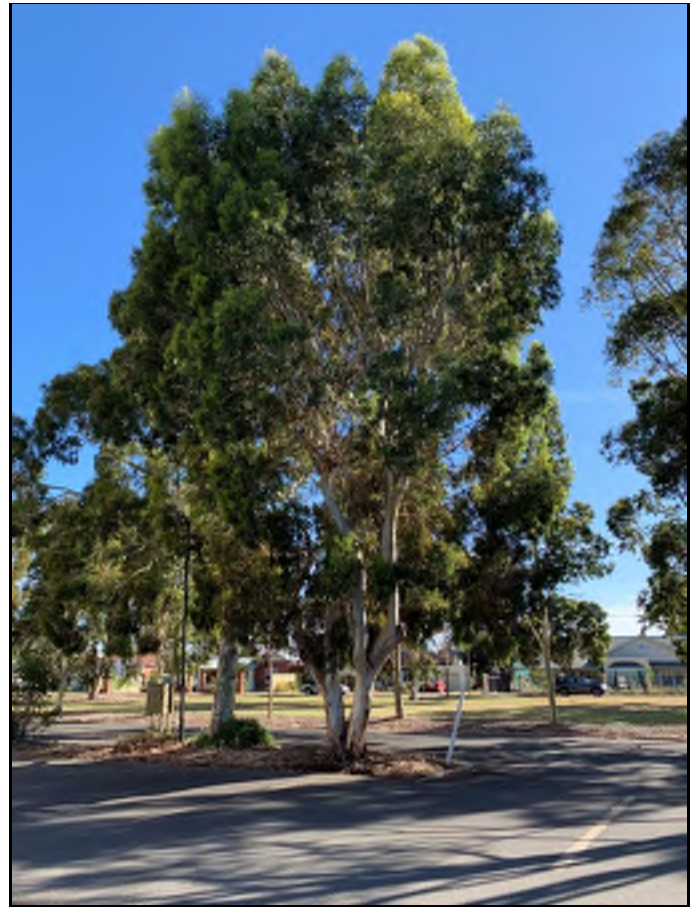
This tree displays good health, however it has poor structure due to having been lopped, the crown now consists entirely of poorly attached epicormic regrowth arising from the lop points. This tree is not sustainable in its current location regardless of the redevelopment of the site.

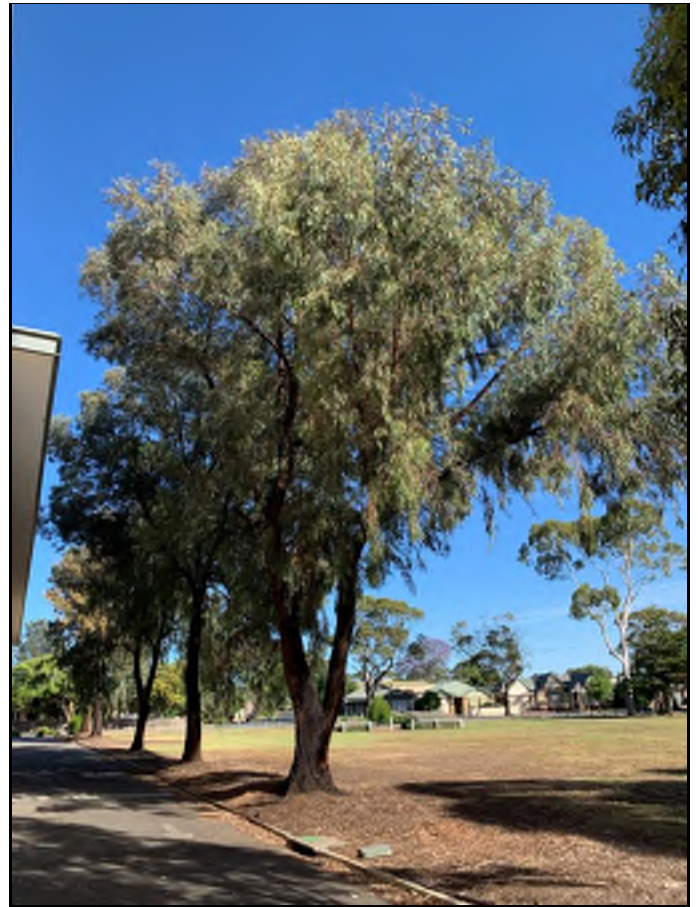
This tree is considered to be in fair overall condition due to the presence of a currently stable included bark union in the mid crown.

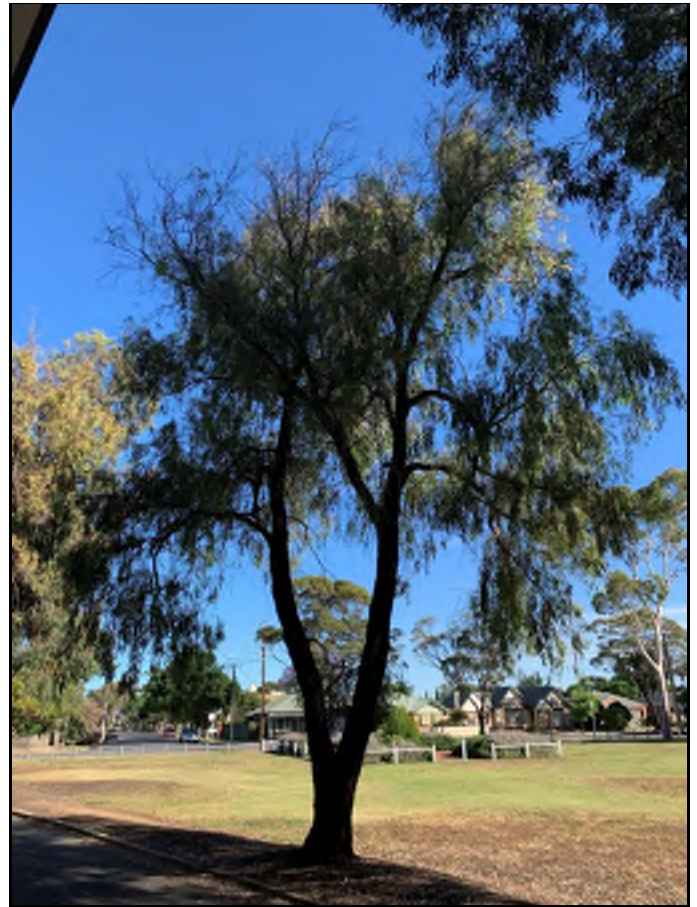
This tree is considered to be in poor overall condition as indicated by the substantially reduced foliage density, the yellowing foliage and the level of the dieback throughout the crown.

Tree removal is required to support the proposed development. This is a poor quality specimen that requires replacement regardless of the proposed development.

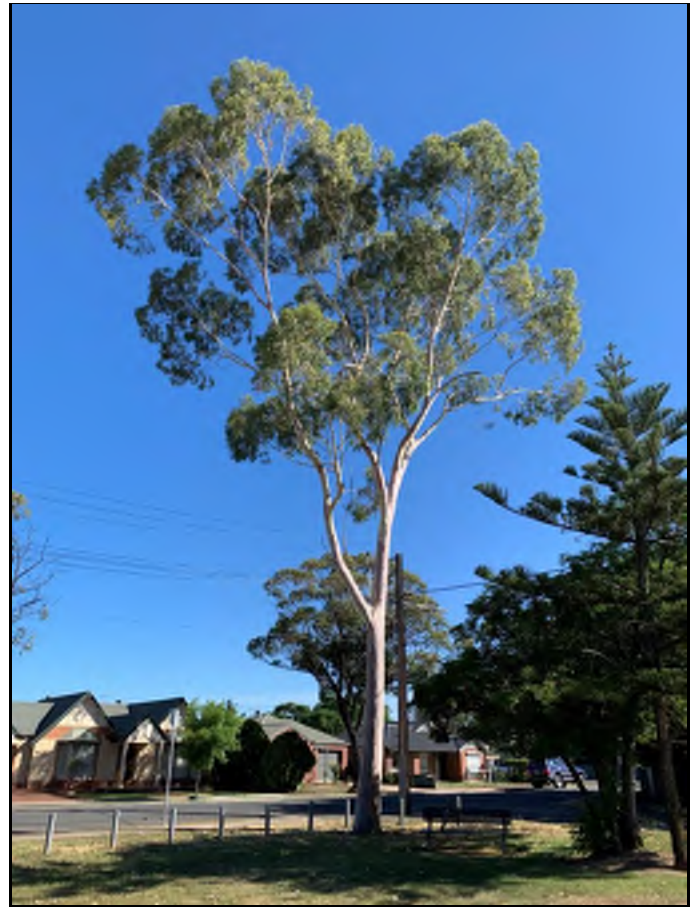
This tree is considered to be in fair overall condition as evidenced by the moderately reduced foliage density throughout the crown and the moderate history of branch failure.

<b>Legislative Status</b>	<b>Regulated</b>
This tree has a trunk circumference greater than two metres and is not subject to any exemption from regulation and therefore it is identified as a Regulated Tree as defined in the Planning, Development and Infrastructure Act 2016.	
<b>Retention Rating</b>	<b>Moderate</b>
This tree has a Moderate Retention Rating and could be considered for retention in any future development.	
<b>Development Impact</b>	<b>No Impact</b>
No encroachment into the Tree Protection Zone area has been identified.	
<b>Recommendation</b>	<b>Protect Root Zone</b>
Protect the root zone of this tree in accordance with the recommendations and principles of AS4970-2009.

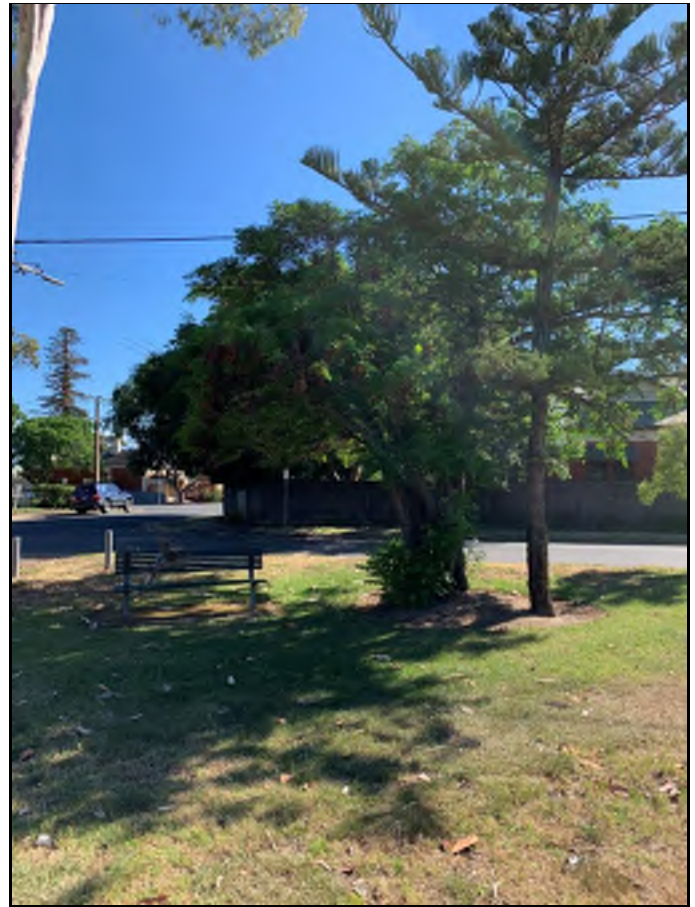
This tree appears to be epicormic growth arising from the stump of a previously removed tree.

Protect the root zone of this tree in accordance with the recommendations and principles of AS4970-2009.

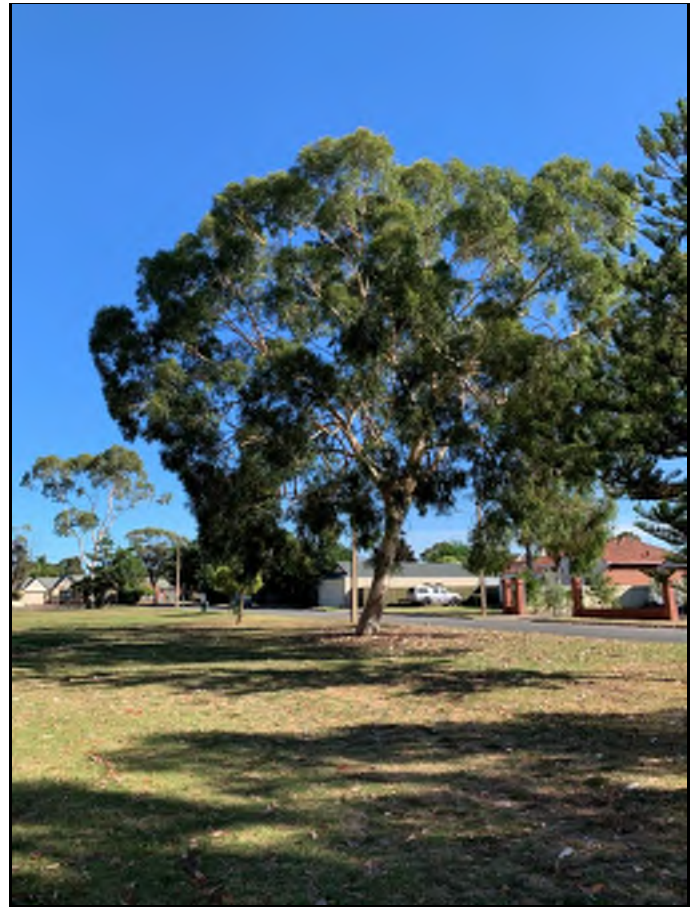
The health and structure of this tree indicate it is in good overall condition and has adapted to its local environment.

<b>Legislative Status</b>	<b>Regulated</b>
This tree has a trunk circumference greater than two metres and is not subject to any exemption from regulation and therefore it is identified as a Regulated Tree as defined in the Planning, Development and Infrastructure Act 2016.	
<b>Retention Rating</b>	<b>Moderate</b>
This tree has a Moderate Retention Rating and could be considered for retention in any future development.	
<b>Development Impact</b>	<b>Conflicted</b>
The identified encroachment is greater than 10% of the TPZ area and will also impact the SRZ and the trunk. There is no opportunity to retain this tree in the current design and its removal is required as part of the development.	
<b>Recommendation</b>	<b>Removal Required</b>
Tree removal is required to support the proposed development. This tree appears to be shown to be retained however given the volume of work in its root zone its successful retention is not realistic.

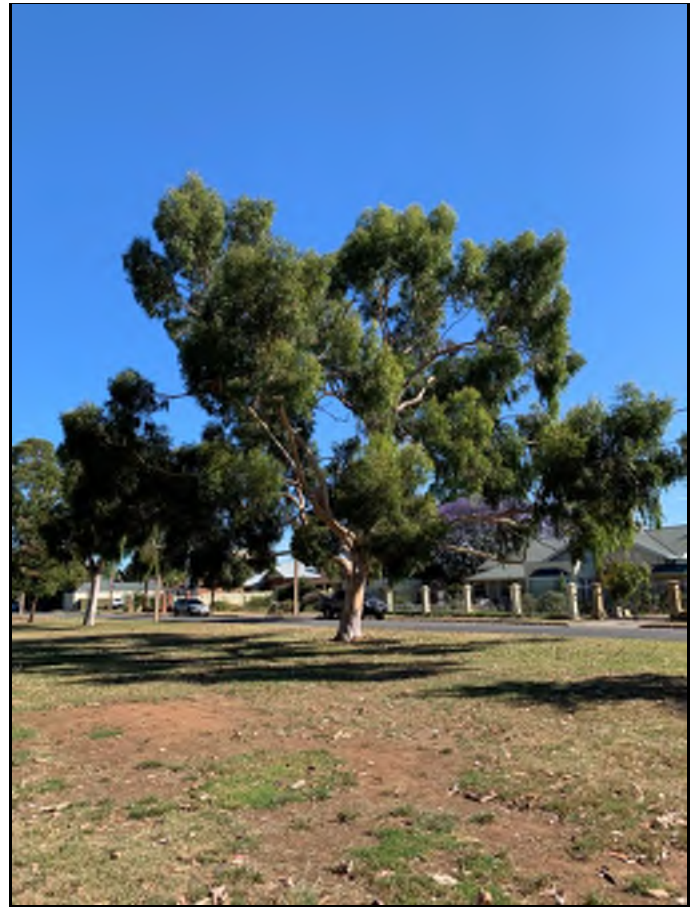
The health and structure of this tree indicate it is in good overall condition and has adapted to its local environment.

Legislative Status	Regulated
This tree has a trunk circumference greater than two metres and is not subject to any exemption from regulation and therefore it is identified as a Regulated Tree as defined in the Planning, Development and Infrastructure Act 2016.	
Retention Rating	Moderate
This tree has a Moderate Retention Rating and could be considered for retention in any future development.	
Development Impact	Conflicted
The identified encroachment is greater than 10% of the TPZ area and will also impact the SRZ and the trunk. There is no opportunity to retain this tree in the current design and its removal is required as part of the development.	
Recommendation	Removal Required
Tree removal is required to support the proposed development.

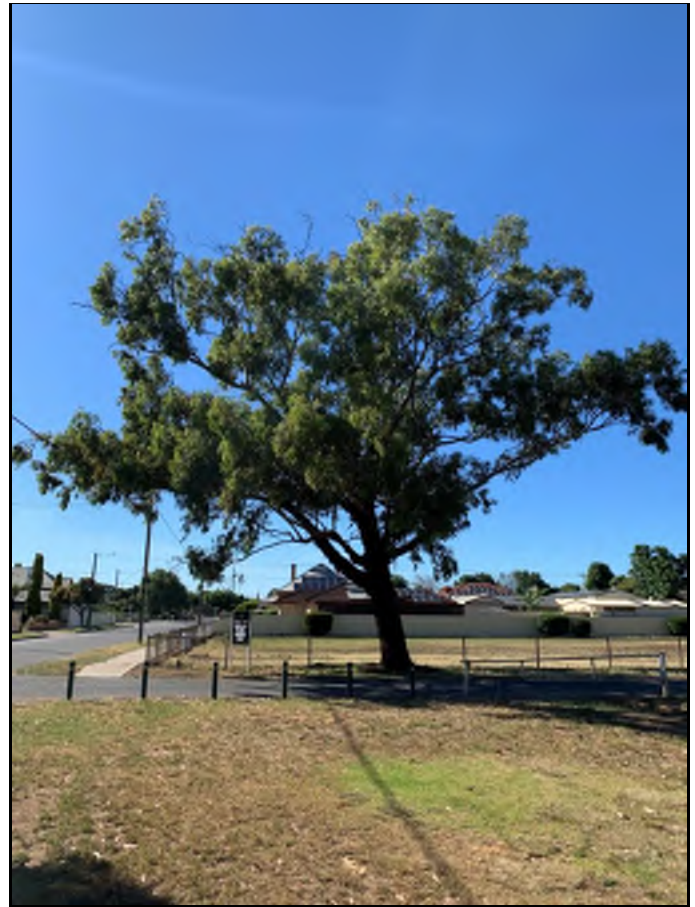
This tree is considered to be in fair overall condition as evidenced by the moderate level of dieback of branch tips and borer activity in the trunk.

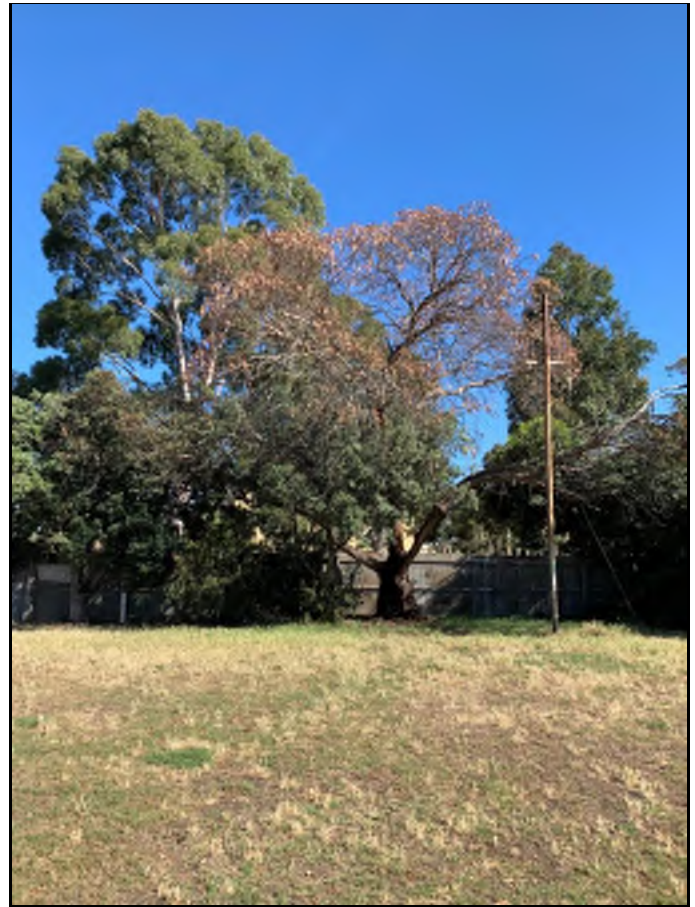
The main trunk is dead with only two live branches remaining, this tree has no realistic potential for remediation.

Tree removal is required to support the proposed development. This is a poor quality specimen that requires replacement regardless of the proposed development.

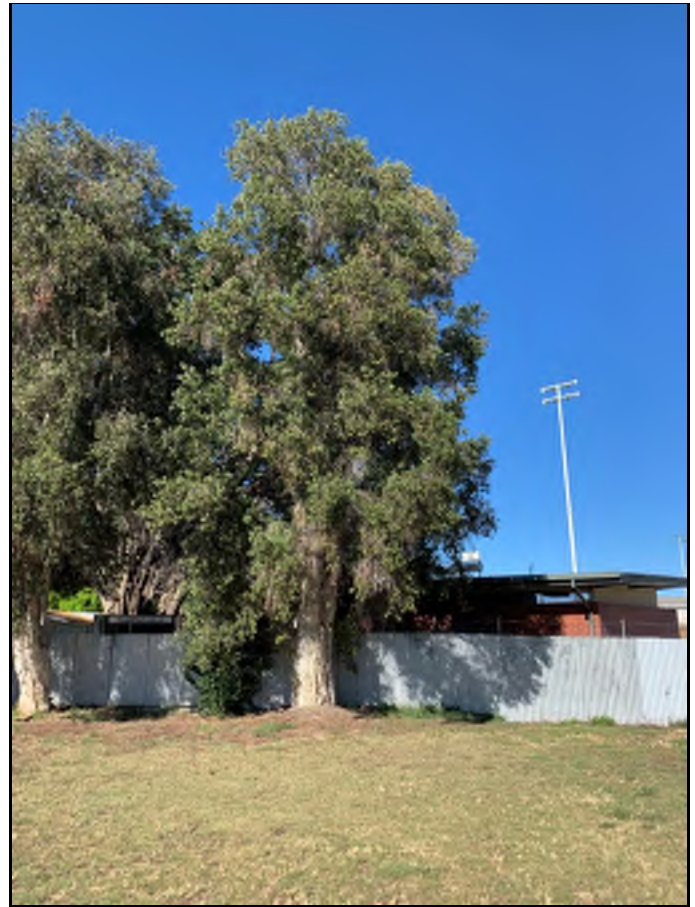
This tree is considered to be in fair overall condition due to the presence of a currently stable included bark union in the primary trunk division.
