Ref. JC0361_LSUM-01

RE: Regency and Days Road, Proposed Croydon Park Rezoning Area – Summary of Environmental Condition

Detailed Site Investigation Lot 2, 3 102, 111 and 114, Croydon Park South Australia

Prepared for:	Salandra Group
Date:	28 August 2019
Reference No:	JC0361
Report Version:	JC0361.DSI/01b

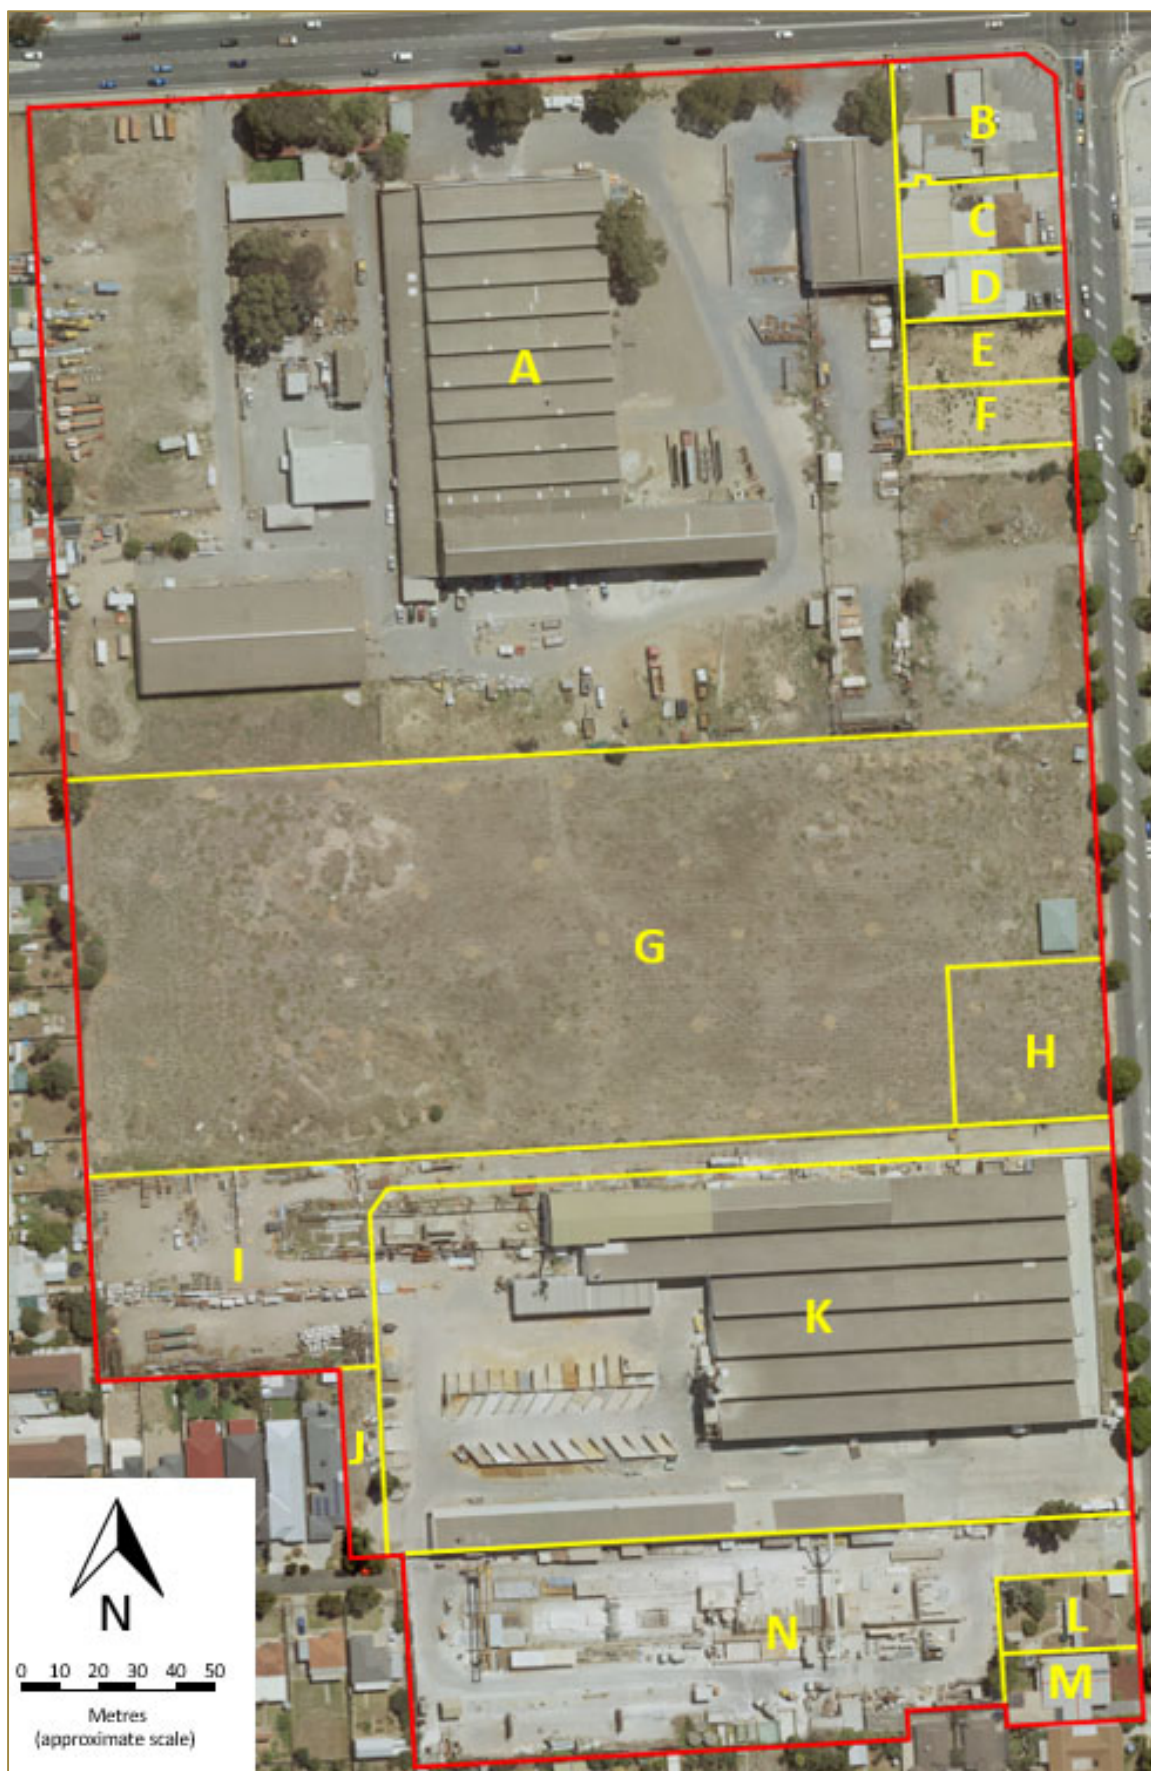
Figure 2: Allotment Plan
 Source: Location SA Viewer (DPTI 2019)

The location and approximate bounds of each allotment within the proposed rezoning area has been provided in Figure 2.

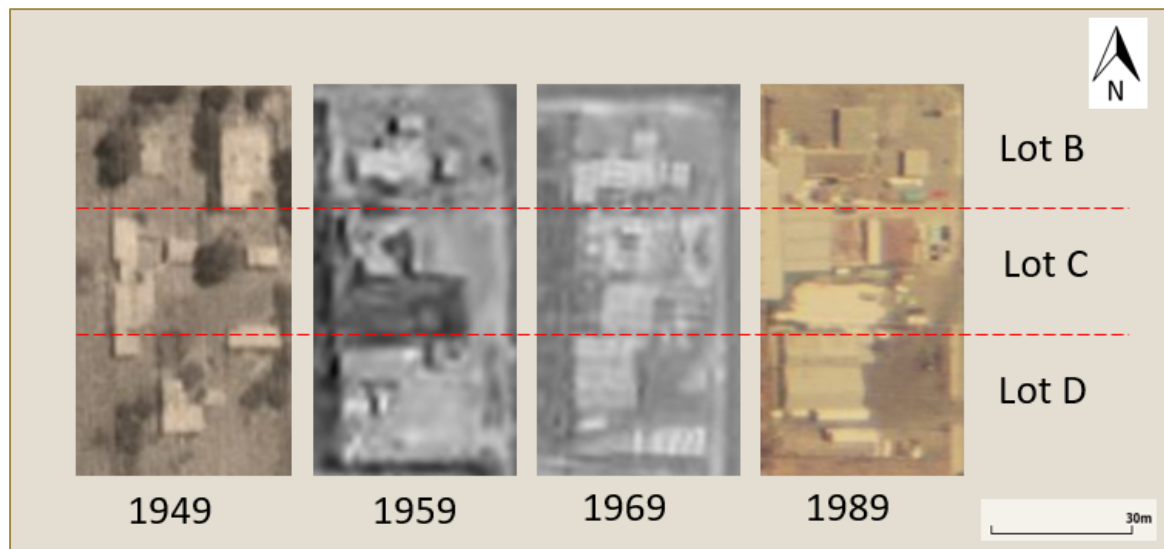
Figure 3: Lot B, C and D Historical Aerials

Site infrastructure appears to have changed during 1959 when commercial/industrial operations began within the local area. The residence in Lot B appears to have been replaced with another structure towards the western portion of Lot B. The smaller sheds previously identified within Lot C and Lot D have been replaced much larger buildings. The 1959 structure within Lot B appears to be a building with a canopy to the north (consistent with the layout of a service station). This layout persisted over time and exist to the present day.

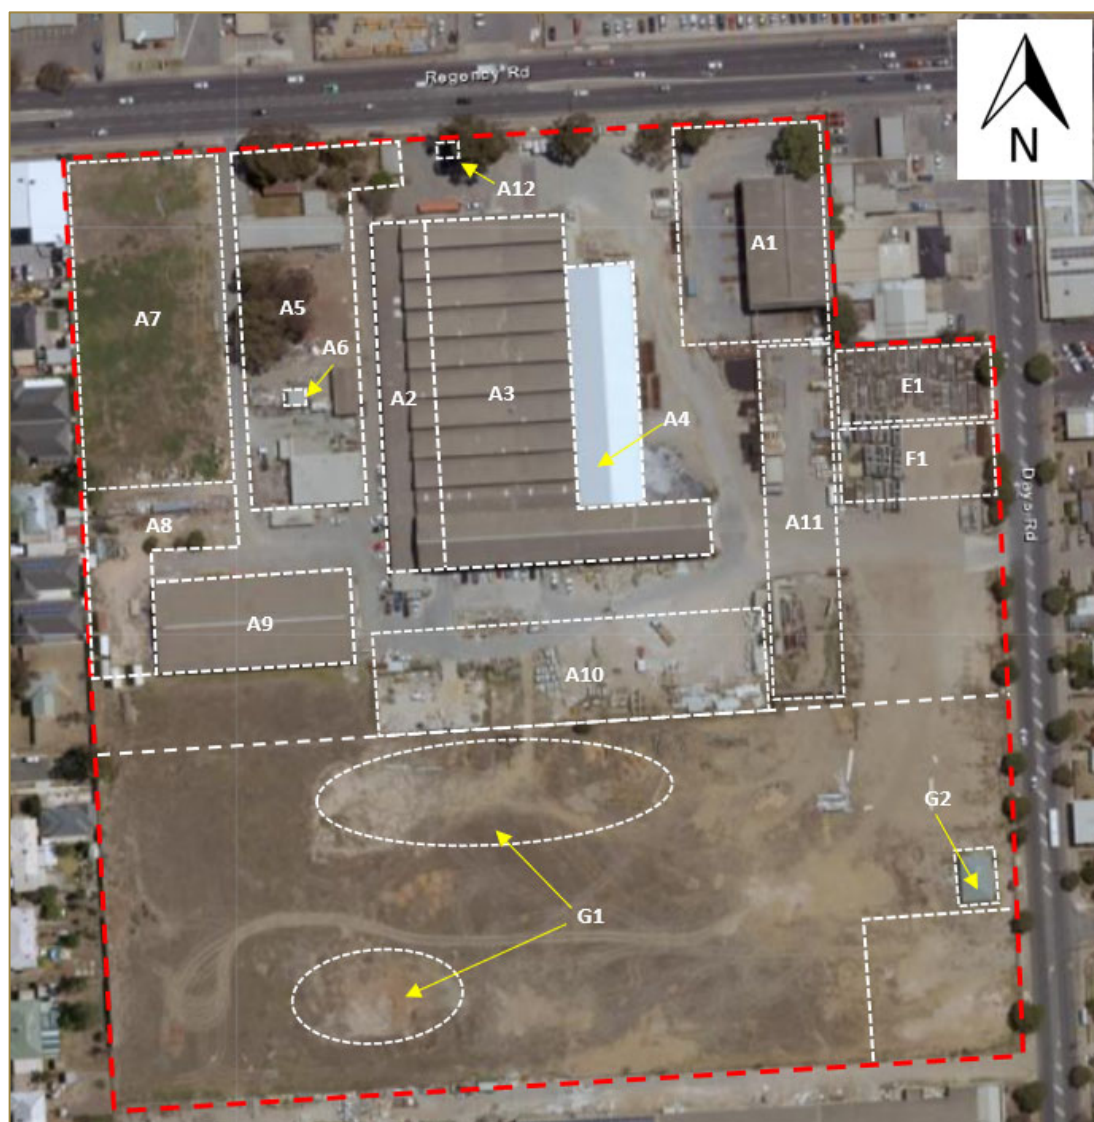
Figure 4: Site Use and Features Plan

- Primary storage and laydown areas are generally unsealed at (eastern portion of A1, A10, E1 and F1). However, the presence of stains or soil discoloration was generally not evident within surface soils throughout the site to indicate leaks and spills from chemicals including fuels;

- Agon could not identify whether the drum platform (A6) was currently storing petro-chemical products;
- The transformer (A12) did not show any indication of leaks or damage which could indicate previous leaks of insulating fluids.

Lot ID		Identified Site Use	
Site Use Ref (see Figure 4)		Identified Tennant	Summary of operations
A	A1	Raisebore Australia	Maintenance of drilling equipment including refurbishment of drilling augers and storage of drilling products/equipment.
	A2	Stoddart	Production of precast metal forms
	A3	Adelaide Integrated Precast	Production of precast concrete forms
	A4	Bianco Precast Flooring	
	A5	Composed of vacant buildings (offices and warehouses). At the time of assessment, hard waste refuse was being stored within this portion of the site.	
	A6	Is a former drum platform for the storage of petroleum products	
	A7	Is a vacant portion of the site historically used for staff car parking	
	A8	Tenant unknown	For the storage of plumbing equipment
	A9	Bianco Timber Truss	Production of timber ladder and A-frames for residential structures
	A10	Temporary product and equipment storage and mobile plant parking area.

A11	In abandoned gantry-style overhead crane alignment. It is being utilised for product and equipment storage.	
	A12	An active transformer is present along the northern boundary	
E	E1	Temporary product and equipment storage and mobile plant parking area.	
F	F1		
G	G1	Soil stockpiling area.	
	G2	Abandoned building. This building is un disrepair with portion of the structures and furnishing removed.	
H	-	Vacant. No notable features.

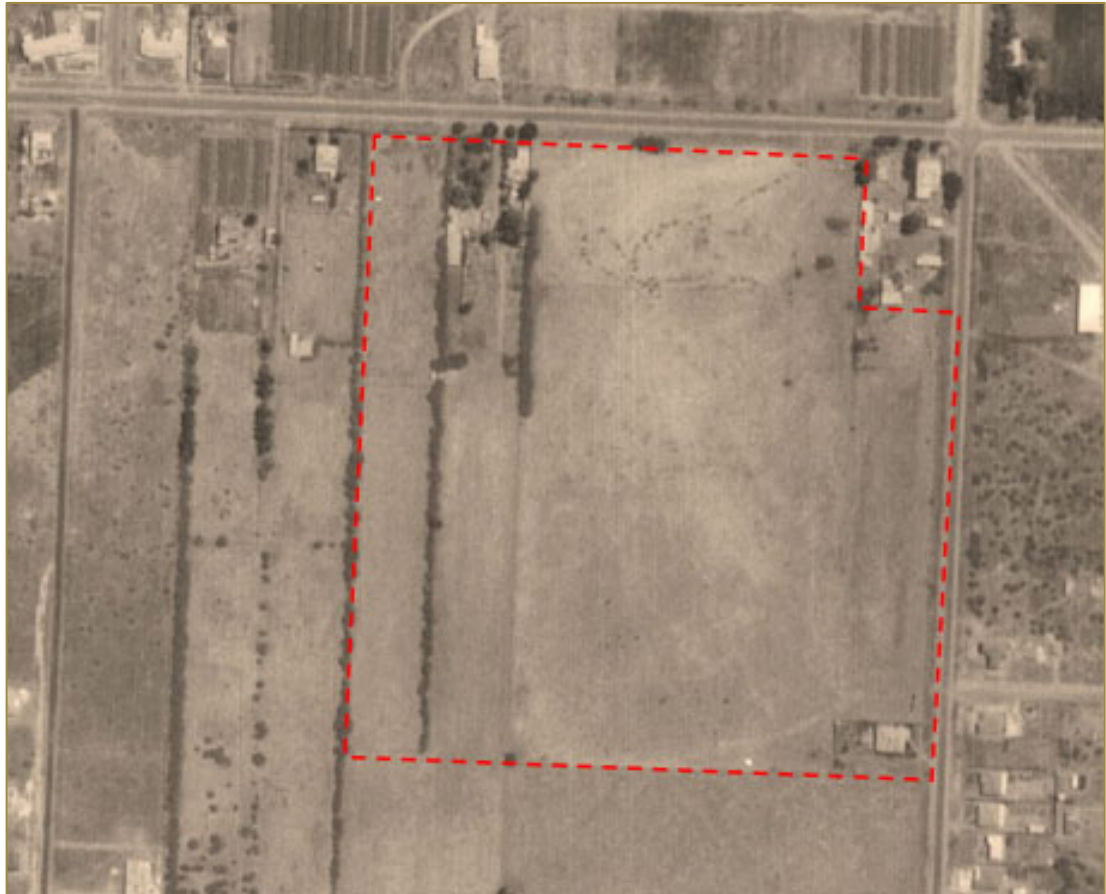
Figure 7: 1949 Aerial Photograph

A copy of the 1949 photograph showing the approximate outline of site (bordered in red) is presented as Figure 7 below.

Historical aerial photographs were previously obtained from DEW (Mapland). A selection of these photographs taken at intervals of around ten years from 1949 (the earliest available photograph) were reviewed by Agon. Relevant historical aerial photographs (from 1949, 1959, 1969 and 1989) have been provided and summarised below.

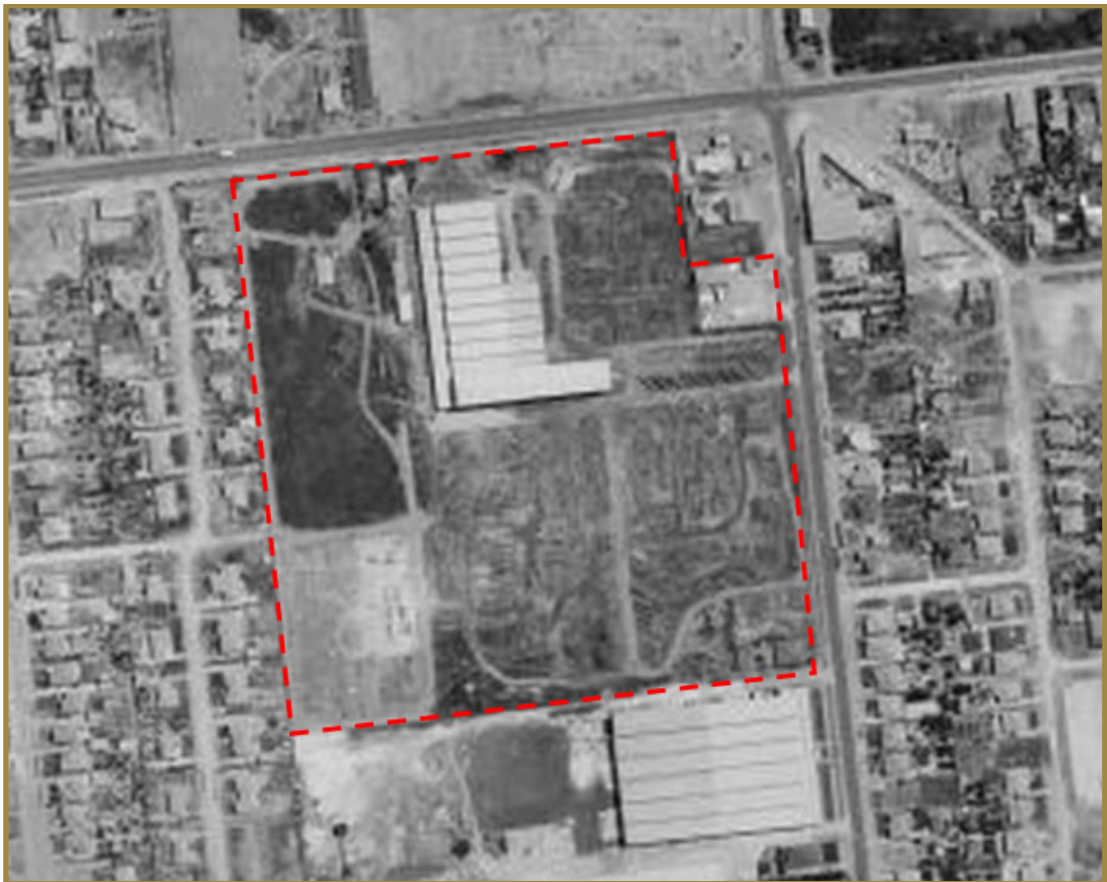
Figure 8: 1959 Aerial Photograph

A copy of the 1959 photograph showing the approximate outline of site (bordered in red) is included as Figure 8.

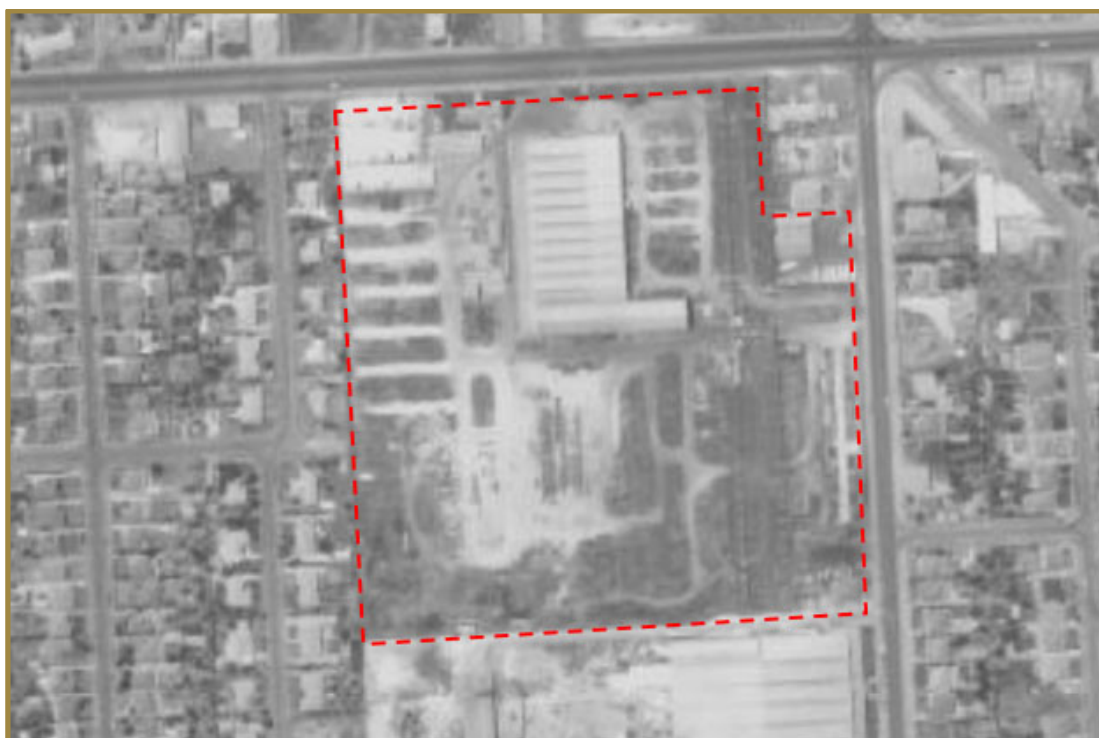
Figure 9: 1969 Aerial Photograph

The 1959 and 1969 aerial photograph (Figure 9) shows what appears to be additional warehousing towards the north-west. The crane gantry is visible and further roadways and soils disturbances are visible throughout (suggesting likely infilling activities).

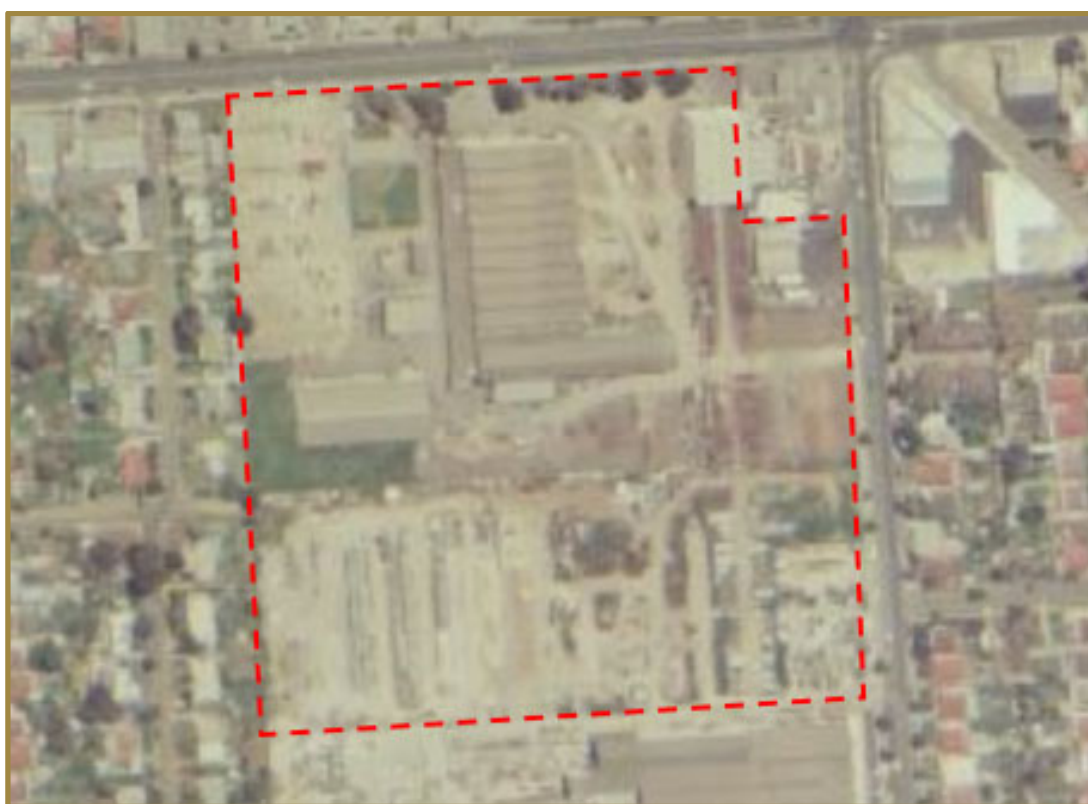
Figure 10: 1989 Aerial Photograph

The site appears to be utilised for open air storage of materials, with materials visibly laid out in rows on the 1989 photograph, Figure 10 below. These materials could be associated with both on-site activities and activities associated with the property to the south, which was then operating as Pioneer Concrete. Further sheds/warehouses have been established within Lot A and the configuration observed is not dissimilar to present day.

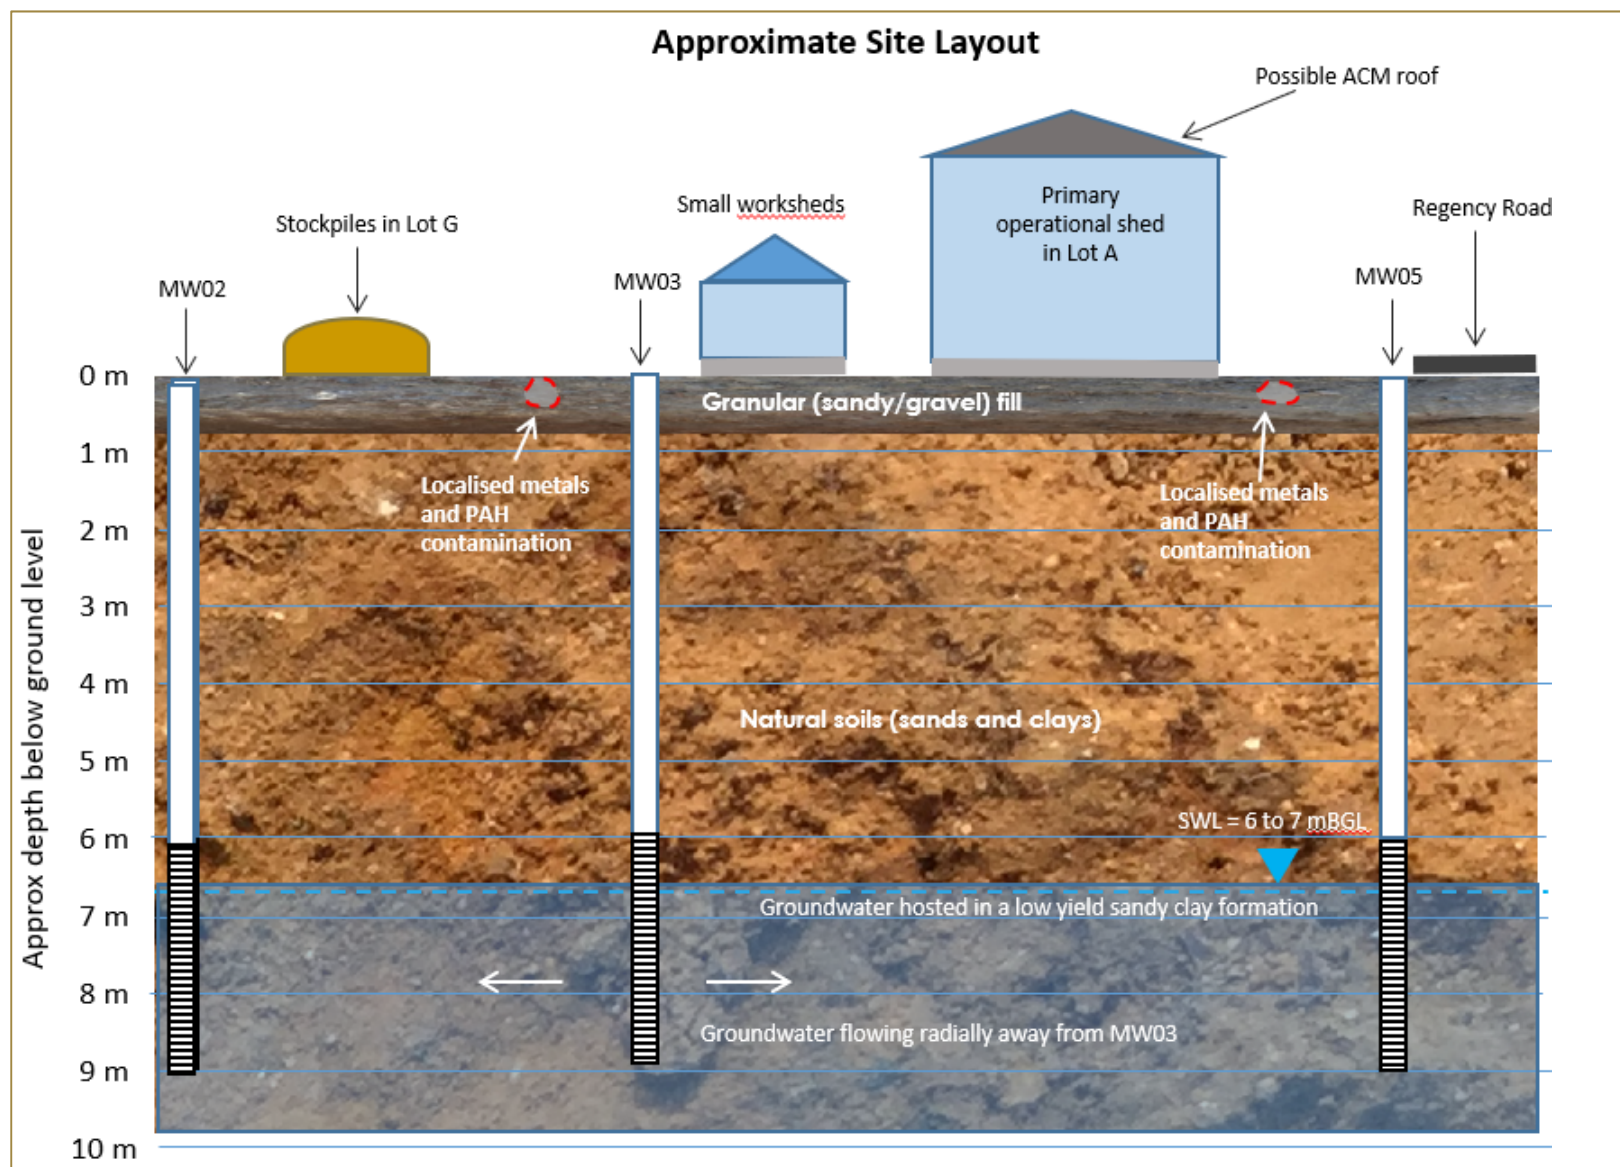
Figure 14: Conceptual Site Model (view to north)

Based on the findings of the current assessment, the following CSM has been developed for the site in Figure 14.
